**HAAKE LAKE DAM**

**CASS COUNTY, MISSOURI**

**MO 20379**

**PHASE 1 INSPECTION REPORT  
NATIONAL DAM SAFETY INSPECTION**

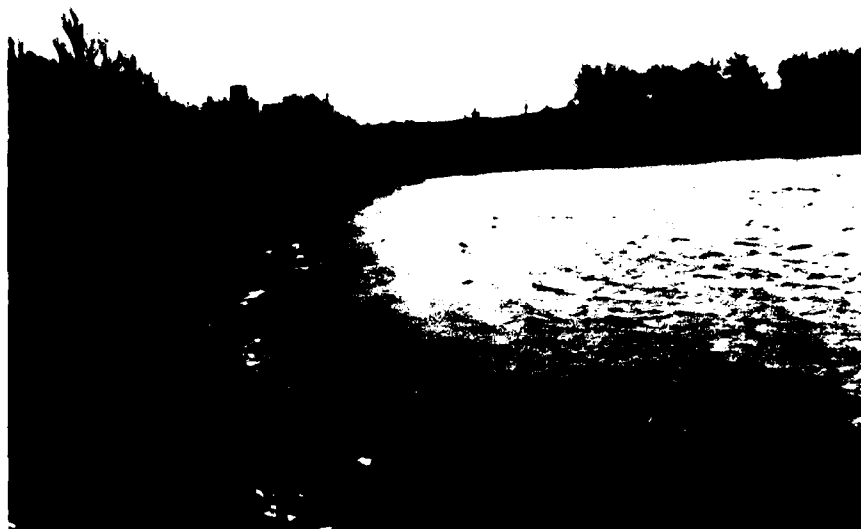
b. Dam. The inspection team observed the following items at the dam. No surface cracks or unusual movement of the embankment were found. A large animal burrow was found in the upstream face of the dam near the center. The depth of the burrow was unknown. There was no problem of sloughing or erosion of the embankment or abutment slopes. There was no riprap on the upstream face of the dam, but no problem of erosion was sighted. Growth of brush and trees was moderate to heavy on the downstream slope of the embankment. Two points of seepage were noticeable near the toe of the dam about 150 feet from the right abutment. These spots were wet, but there was no visible flow from them. Seepage was also detected in the left abutment downstream of the dam and right of the emergency spillway. Water was flowing from this spot at a rate of approximately two gallons per minute. The lake level at the time of the inspection was at full pool elevation. There was a small amount of flow over the principal spillway. The downstream embankment slope appears excessively steep and the stability criteria set forth in the guidelines probably will not be met.

PHOTO 1: UPSTREAM FACE OF DAM LOOKING EAST

(1) Further animal burrowing in the upstream face of the embankment should be prevented and the holes should be filled in with properly compacted material. Burrowing animals (muskrats and ground squirrels) have been responsible for piping failures in a number of small earth dams. If willows or other brush grow at the water line, muskrats will dig under them because the roots reinforce the opening of the hole and also hide its existence.

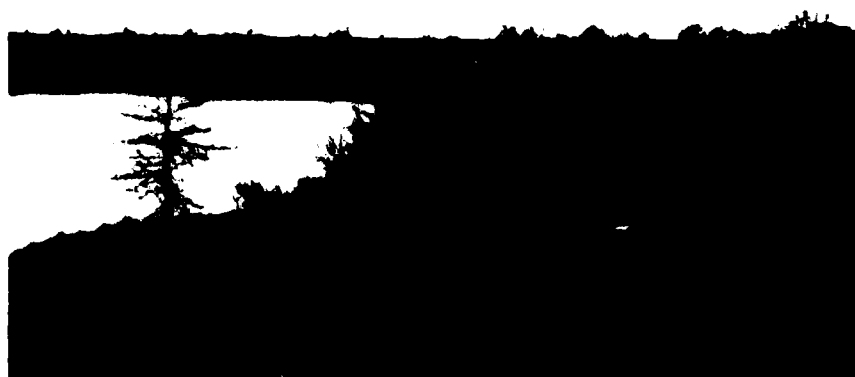
PHOTO 4: CREST OF DAM LOOKING WEST

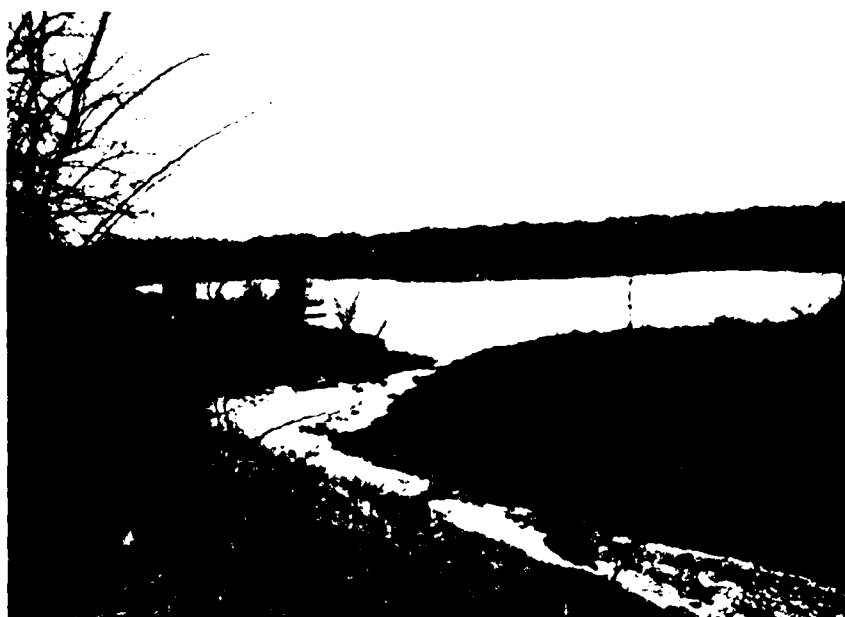
c. Appurtenant Structures. The inspection team observed the following items pertaining to appurtenant structures. The earth and rock channel of the principal spillway appears to be in good condition with no evidence of erosion of either the bottom or side slopes of the channel. The bottom of the channel is partially formed by an intermittent layer of sandstone. This spillway discharges over a rock ledge to the natural channel downstream of the dam.

PHOTO 9: PRINCIPAL SPILLWAY LOOKING UPSTREAM

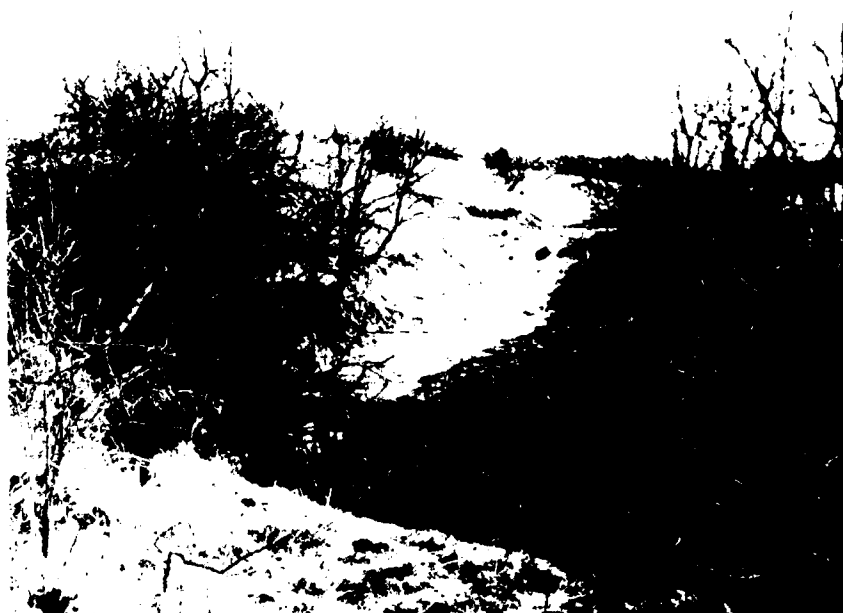
PHOTO 10: PRINCIPAL SPILLWAY CHANNEL AND FALLS LOOKING UPSTREAM
